NATIONAL TRANSPORTATION SAFETY BOARD

Fire & Explosion Group Factual

Accident Number: DCA06MF016
Operator: Massachusetts Baylines
Location: Boston Harbor
Date: June 12, 2006
Time: Approximately 4:15 pm
Vessel ID #: 927011

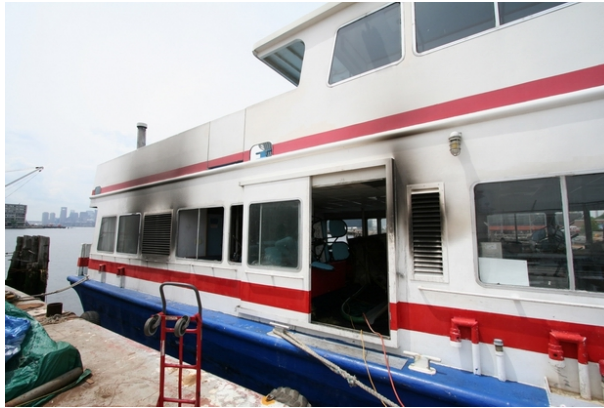
Figure 1: Starboard side of the Massachusetts

The exterior of the vessel did not show signs of any fire damage with the exception of soot stains. These stains were located on the forward and aft grills of the ventilation openings on both sides of the ship (Figure 1). These stains also extended to the areas above and slightly to the sides of the openings. The starboard side was more heavily soot stained than the port side. The forward vents which facilitate the air intake to the engine room appeared to have less soot markings around them as compared to the aft vents which provided the exhaust path for the engine room ventilation. With the exception of the soot markings and a few broken windows¹ the vessel did not sustain significant damage to its exterior from the engine room fire.

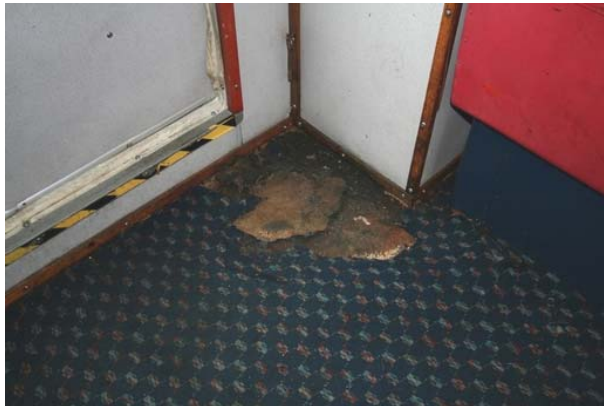
The interior of the main deck did not show signs of fire damage, with the exception of a spot on the floor where the carpet was charred (Figure 2). This location where the carpet was charred on the floor was adjacent to the casing of the forward vent stack to the engine room on the port side of the vessel. There was also a light dusting of soot covering some surfaces on the main and upper decks. There were some broken windows which occurred during the fire fighting efforts.

Figure 2: Charred carpet on main deck, adjacent to vent stack

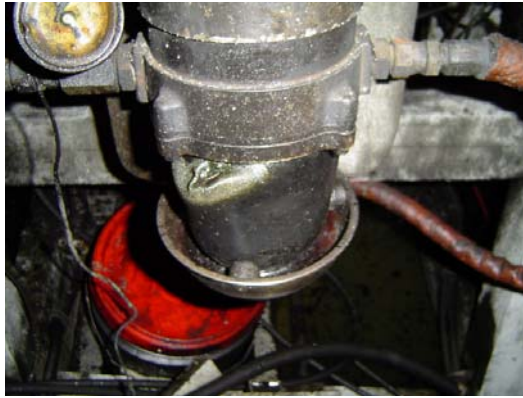
The supply and return lines for the lubrication system of the inboard turbo were found to be intact. The supply and return lines for the lubrication system of the outboard turbo were also found to be intact. The fuel lines from supply to return were found to be intact. The bowl portion of the fuel filter was found to be deformed and appeared to have a slow leak, as witnessed by a small accumulation of diesel in the heat shield underneath it (Figure 4). The bowl of the fuel filter was made from plastic. The oil lines to and from the external oil filtration system (located on the starboard bulkhead) were intact. The oil level in the sump was measured to be normal² according to the reading obtained from the dip stick. There was evidence of thermal damage to the top and mid section of the engine in the form of burnt through coolant lines (water is used as the coolant) and wires that had melted insulation. The paint on the exhaust and engine block was undamaged. The thermal lagging on the exhaust was intact. Overall the damage indicates that the engine sustained a thermal exposure from the top down.

Figure 4: Plastic bowl of fuel filter on Starboard outboard engine

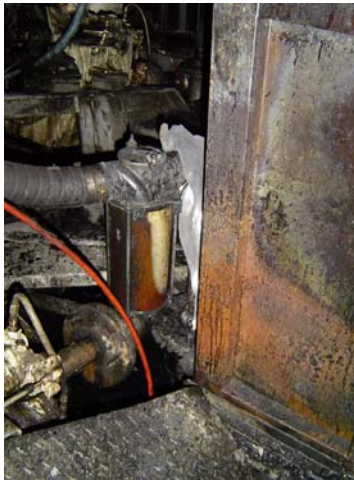
The supply and return lines for the lubrication system of the inboard turbo were found to be intact. The supply and return lines for the lubrication system of the outboard turbo were also found to be intact. The thermal lagging on the turbo chargers and exhaust was intact. The fuel lines from supply to return were found to be intact. The bowl portion of the fuel filter was found to be intact. The oil lines to and from the external oil treatment system (located on the starboard bulkhead) were intact. The oil level in the sump was normal as measured from the dipstick. There was evidence of thermal damage to the top section of the engine in the form of burnt through coolant lines (water is used as the coolant) and wires that had melted insulation. The paint on the exhaust and engine block was undamaged. The water strainer aft of the engine showed thermal damage³ in a section facing the rear of the port inboard engine (Figure 5).

³ The thermal damage was characterized by small bubbles and blistering of the plastic material causing a white appearance.

Figure 5: Water strainer behind Starboard inboard engine

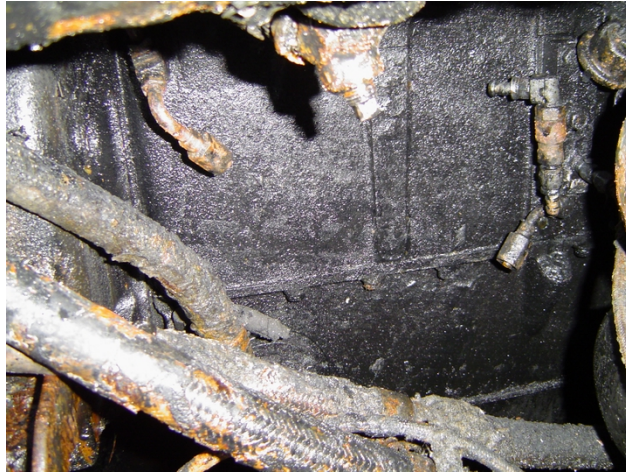
The supply and return lines for the lubrication system of the inboard turbo were found to be connected at both ends but having sustained significant thermal damage⁴. The supply and return lines for the lubrication system of the outboard turbo were also found to be connected at both ends and exhibiting substantial thermal damage. Specifically these lines had become brittle and the rubber portion had melted away leaving the armor behind. The fuel line from the supply to the fuel filter was intact. The bowl portion of the fuel filter was missing. The fuel line to the fuel cooler was severed at the fitting (Figure 7). This fuel line was brittle with just the armor remaining. The oil return line from the external oil treatment system (located on the port bulkhead) was severed⁵ at a location below the port inboard engine. There was a missing oil line on the inboard side of the engine block (Figure 6). There was no oil left in the sump as determined by checking with the dipstick. There was extensive thermal damage to the entire engine in the form of burnt through coolant lines (water is used as the coolant), wires that had melted insulation leaving behind bare conductors and missing paint. The transmission lubrication lines which were rubber coated armored lines were intact but had lost their rubber coating and had become brittle from thermal exposure. The valve cover on the inboard side was significantly deformed towards the aft section and it had taken on a white oxidized appearance (Figure 8). The valve cover gasket was sticking out from under the valve cover along the inboard aft section. Upon removal of the inboard valve cover it was found that a fuel jumper line associated with the third cylinder from the front was disconnected and sitting above the mating surface below (Figure 9). The air intake manifold downstream of the turbo showed signs of severe heating. Specifically it had taken on a heavily oxidized appearance and exhibited areas of deformation and sagging. The paint on the exhaust and engine block was burnt away with the exception of a few areas in the front of the engine. The water strainer aft of the engine was melted along the surface facing forward, towards the port inboard engine (Figure 10). The inboard engine mounting rail was slightly bent inboard and showed signs of cracking along weld seams towards the aft section (Figure 16). The paint on the secondary fuel filter was burnt off along the portion facing towards the rear of the engine and intact along the portion facing towards the front. After removing the air intake filter from the inboard turbo it was found that the compressor blades were severely damaged exhibiting a ragged edge appearance (Figure 11).

⁵ The oil line appeared to have been burnt through and was completely separated.

Figure 6: Missing oil line on lower inboard side of the port inboard engine block

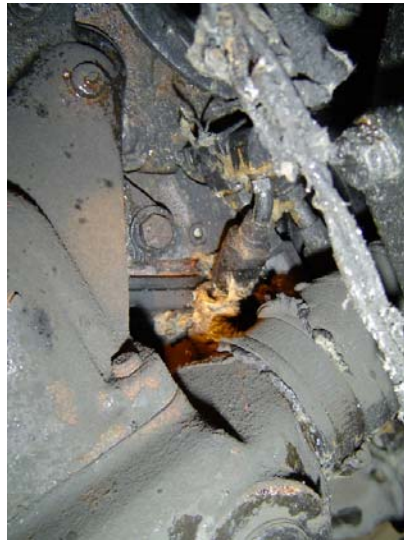
Figure 7: Fuel line to fuel cooler severed at fitting

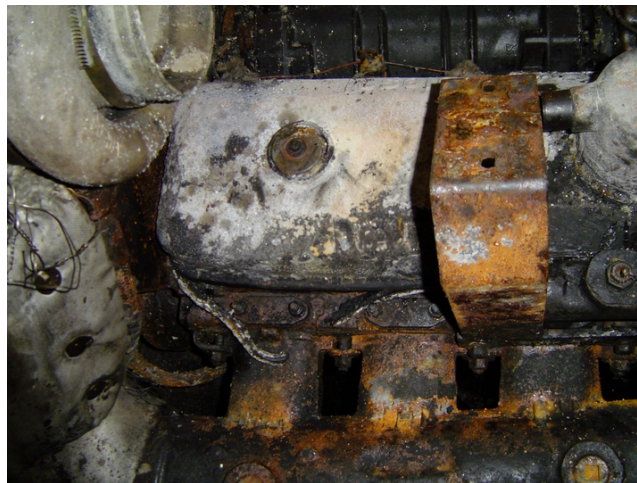
Figure 8: Port inboard engine, inboard valve cover

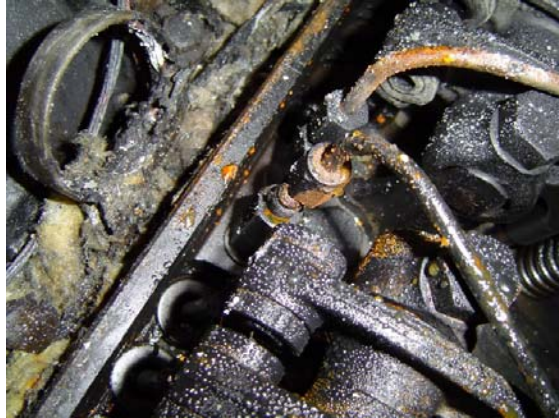
Figure 9: Number 3 cylinder fuel jumper line of port inboard engine, inboard side

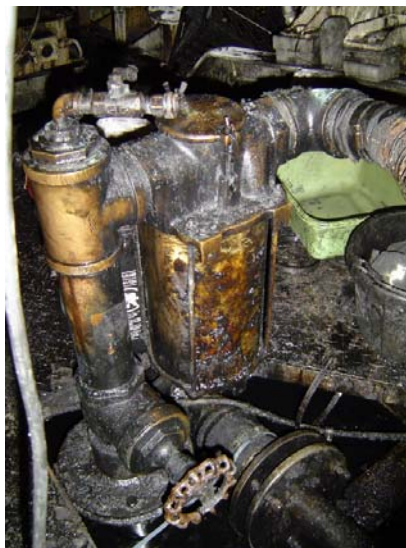
Figure 10: Water strainer aft of port inboard engine

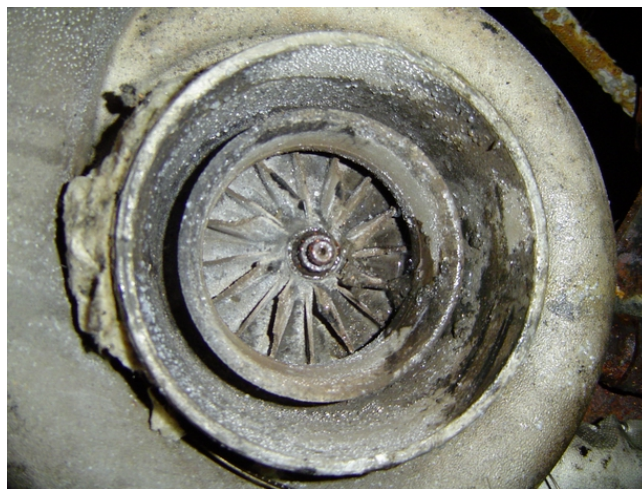
Figure 11: Port inboard engine inboard turbo compressor blades

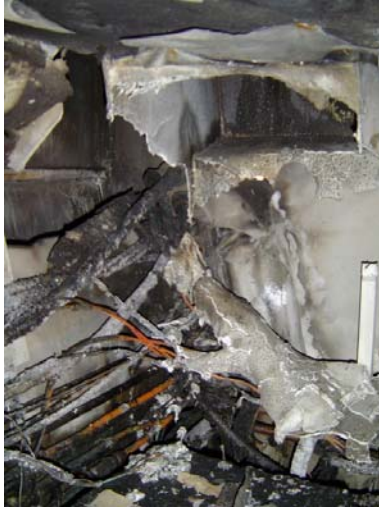
The engine room ventilation system consisted of two air intake vents on either side of the forward bulkhead and two exhaust vents at the rear. The rear vents were coincident with the stair wells, and were natural ventilation. The forward intake vents consisted of an aluminum duct with a cylindrical, electrically driven blower attached (Figure 13). On the port side, the aluminum duct had melted (Figure 12) and the blower was found on the floor below. On the starboard side the intake vent and blower were intact.

Figure 12: Port side air intake duct

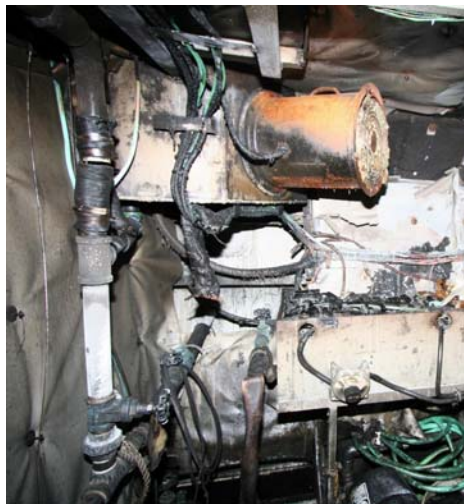
Figure 13: Starboard side air intake duct and blower

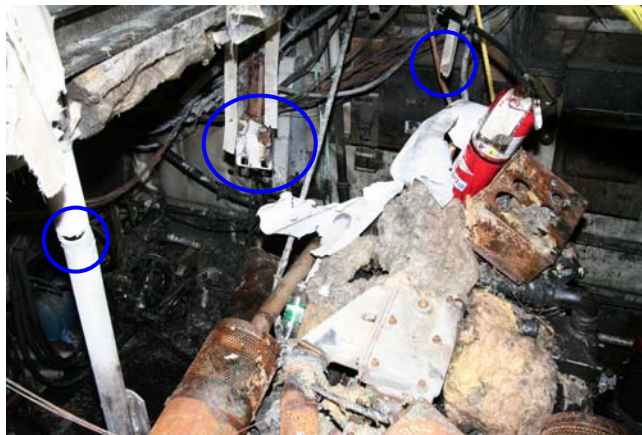
There were some areas with structural damage in the engine room. This damage was characterized by melted and sagging aluminum members and was more extensive in the areas above the port inboard engine and at the location of the fresh air intake vent on the port side of the engine room (Figure 12). There also was damage to the floor decking and the support structure below, inboard and aft of the port inboard engine (Figure 15). Above and to the outboard side of the port inboard engine there were melted and sagging aluminum components (Figure 14). These components consisted of $\sim 1/4$ " thick by 2" wide bars spanning the length of the ceiling. There was a vertical aluminum column spanning from the floor to the ceiling which had softened, fractured, and bent out of alignment in this area also (Figure 14). Along the centerline of the engine room towards the rear of the port inboard engine there was a hole melted through the floor decking. Upon moving the decking it was found that the structure supporting the decking had also melted and severed and in some areas was sagging (Figure 15). Also the inboard engine mount which consisted of an aluminum rail had some cracks along the welds (Figure 16). A diagram showing the locations of the most pronounced fire damage to the vessel's structure and machinery can be seen in Figure 17.

Figure 14: Melted and deformed aluminum members in area above port inboard engine

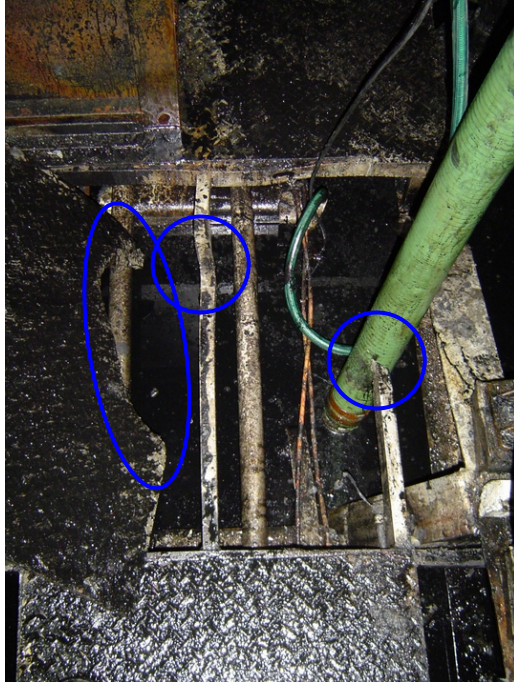
Figure 15: Melted and deformed floor supports and decking

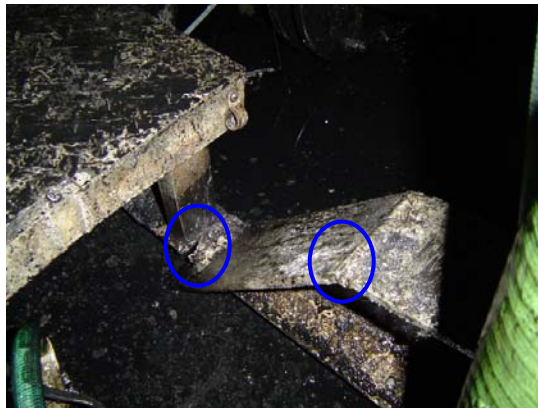
Figure 16: Cracked welds on engine mounting rail of port inboard engine

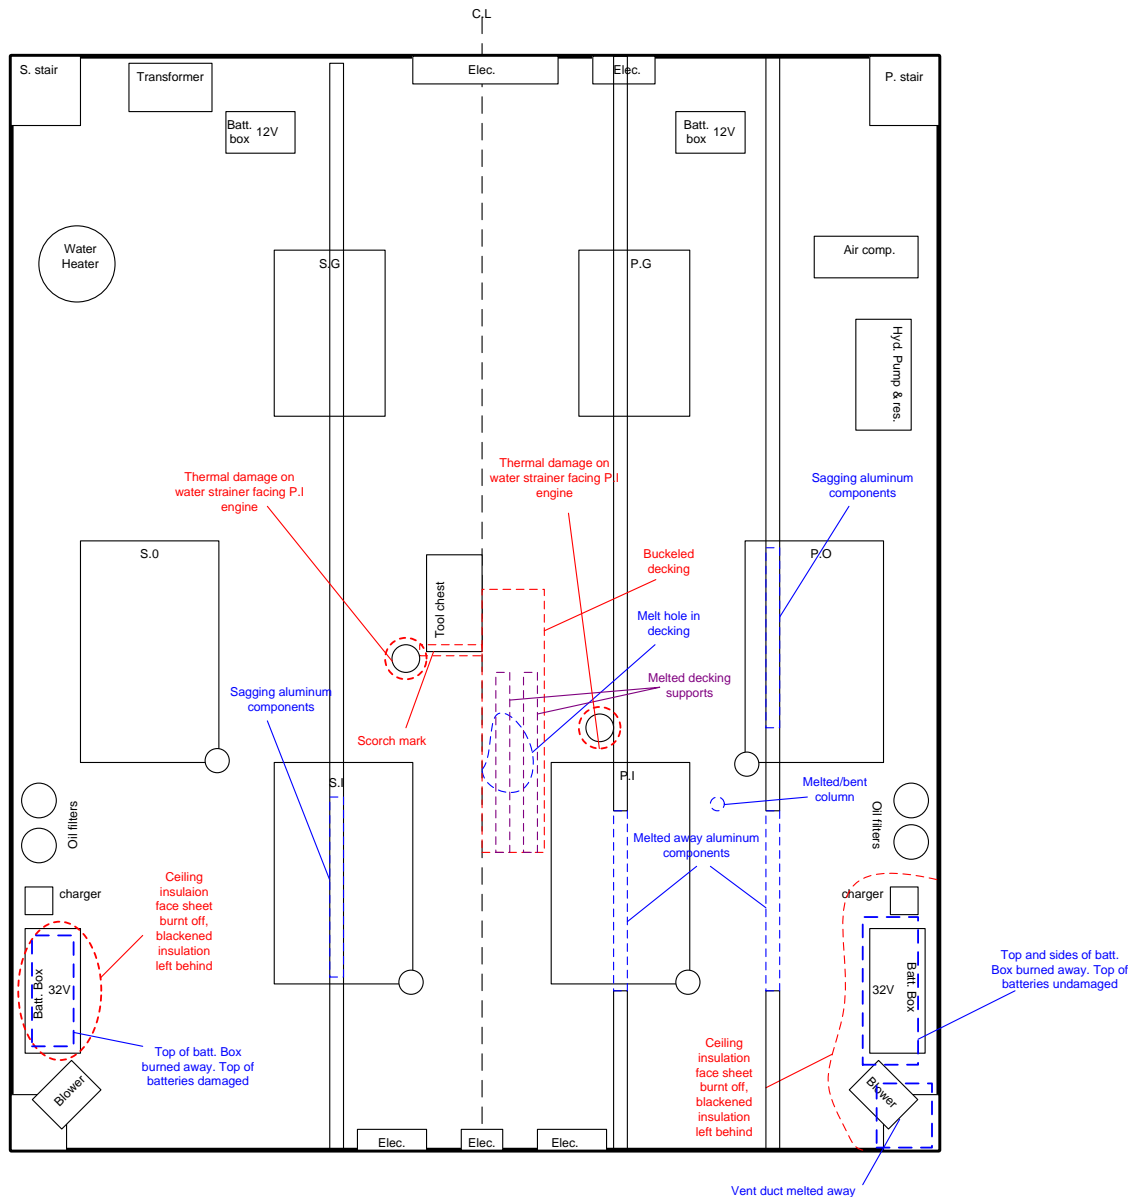
Figure 17: Diagram of most severe fire damage (Not to scale)
